Durability of cutter assemblies and its causative factors

Abstract: Cutter assemblies operate under stressful conditions: the knives are subjected to high dynamic loads, the cutter shaft rotates at a frequency of 5–100 s⁻¹, the electric driving motor of the cutter shaft overcomes high starting moments, the bed is subjected to significant static and dynamic loads, the food raw materials and humid atmospheric air in the production room is corrosive to the structural elements, etc. Under the influence of these factors, the cutter assemblies break down, which causes unregulated pauses in food raw materials processing and also requires high expenses for equipment repair. The aim of the paper was to study the durability of the main cutter assemblies and to establish its main determining factors. The presented numerical values of durability of cutter assemblies have been obtained as a result of the planned, warranty and post-warranty practical maintenance of cutters by the engineering team of GEA FOOD SOLUTIONS UKRAINE, LLC, the mechanical supervisor staff of Cherkassk Food Company, LLC and also as a result of scientific research of the processes that provide the operation of these machi

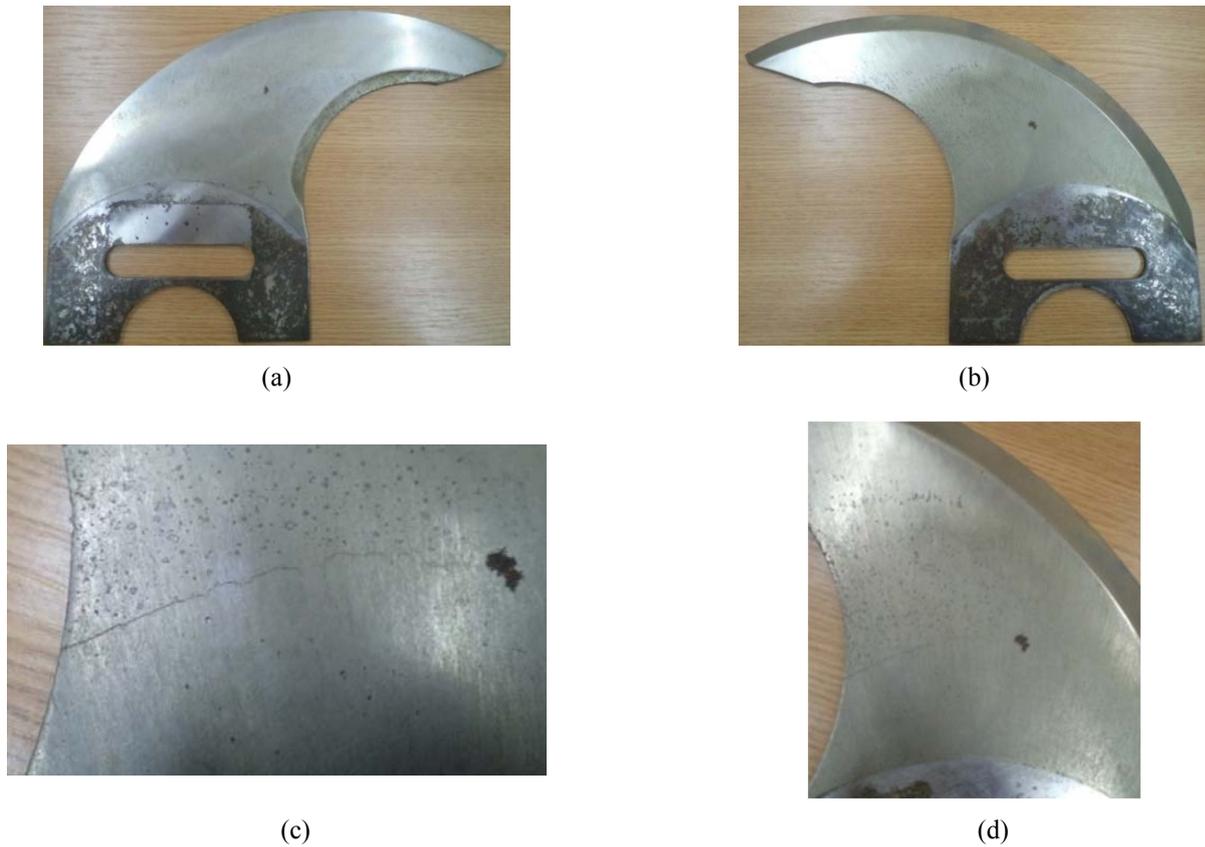
Fig. 7. Fatigue macrocrack on the working surface of the knife body of the L5-FKB cutter: (a) the view of the knife from below, a chamfer on the back edge is shown; (b) the view of the knife from above; (c) the enlarged view of the area the fatigue macrocrack began to develop from; (d) the general view of the macrocrack.

Fig. 7 shows a macrocrack that began to develop on the back edge of the knife of the L5-FKB cutter, the deepest part of the crack is in the stress concentration zone 2 (in accordance with Fig. 2a) on the back edge of the knife.

The data obtained show that the working part of the German-made knife has been polished, while the working part of the Ukrainian-made knife has undergone a grinding operation as finishing. As a result, the L5-FKB knife has a 4-time higher roughness of the working surface, which causes 5–10% of its lower fatigue strength. The back edge of the Laska KR-330-2V knife has a high quality of processing, whereas the back edge of the L5-FKB knife has some significant jags, which is obviously also the source of fatigue cracks in the knife (Fig. 7).

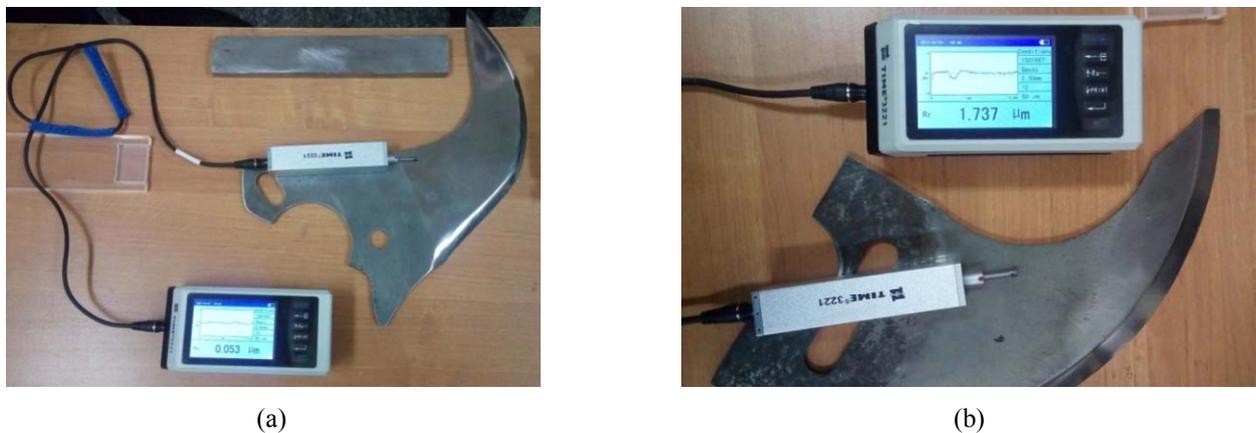
Fig. 8. Measurement of the roughness of the knife surface using a TIME 3221 profilometer: (a) the knife of the Laska KR-330-2V cutter; (b) the knife of the L5-FKB cutter.

The measurement of surface roughness of the knives made in Germany and in the Ukraine (Fig. 8) made it possible to establish that the knives of the Laska KR-330-2V cutter produced by GW Steffens GmbH had a mounting surface with a roughness $R_a = 0.708 \mu\text{m}$ and a working surface with a roughness $R_a = 0.053 \mu\text{m}$. The knives of the L5-FKB cutter had both a working and mounting part with a roughness $R_a = 0.216 \mu\text{m}$.
